## Conservation of Furniture and related objects

### Condition and treatment report

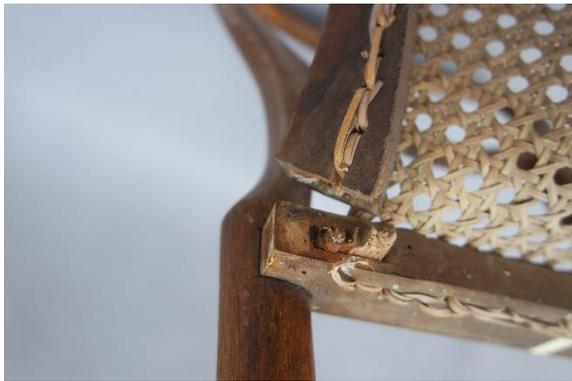
Fig. 5  
Detail of broken joint p. right back corner of the frame.

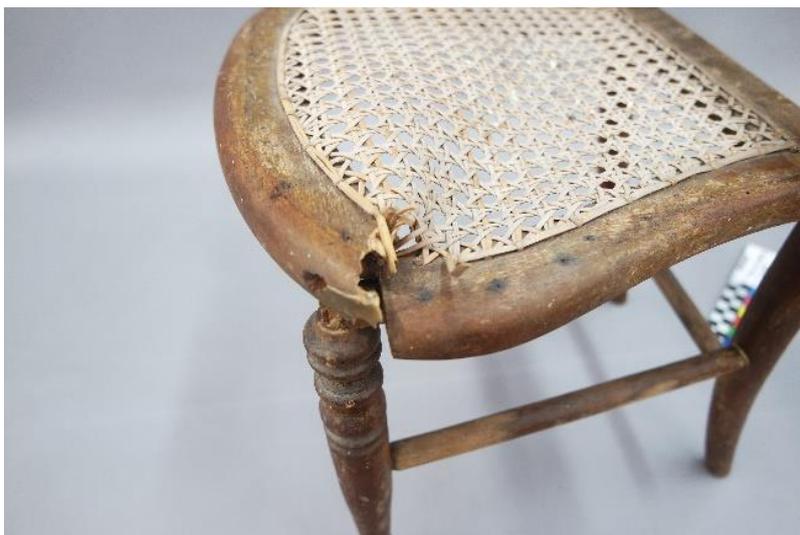
Fig. 7  
Detail of broken joint p. left front corner of the frame.

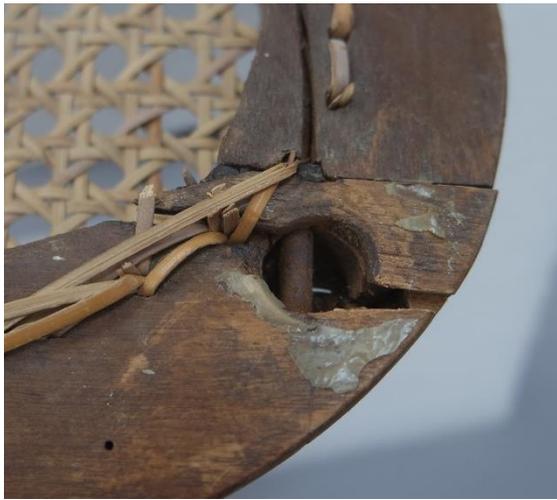
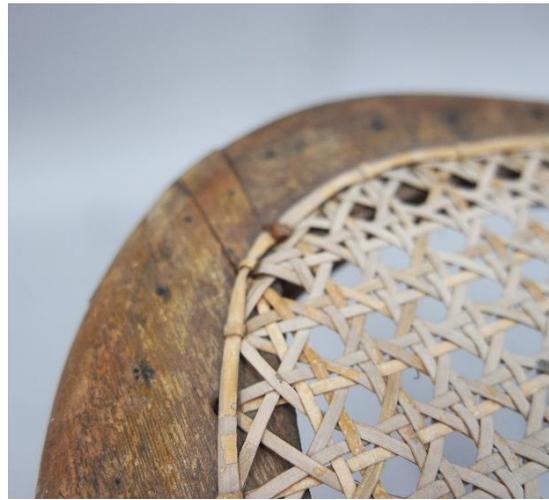
Detail view on the bottom (left) and top (right) of the front right corner of the seat frame.

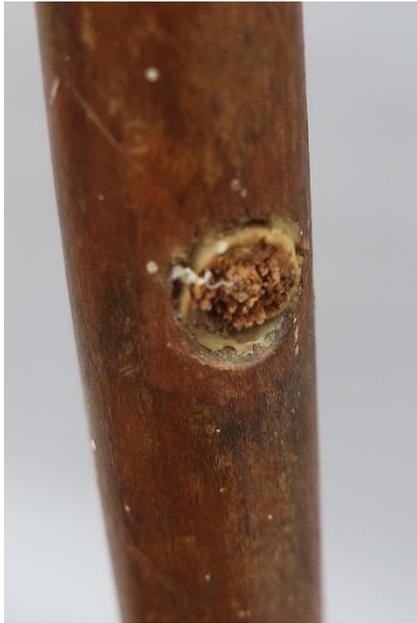
Fig. 14  
Detail broken of stretcher in the p. right upright

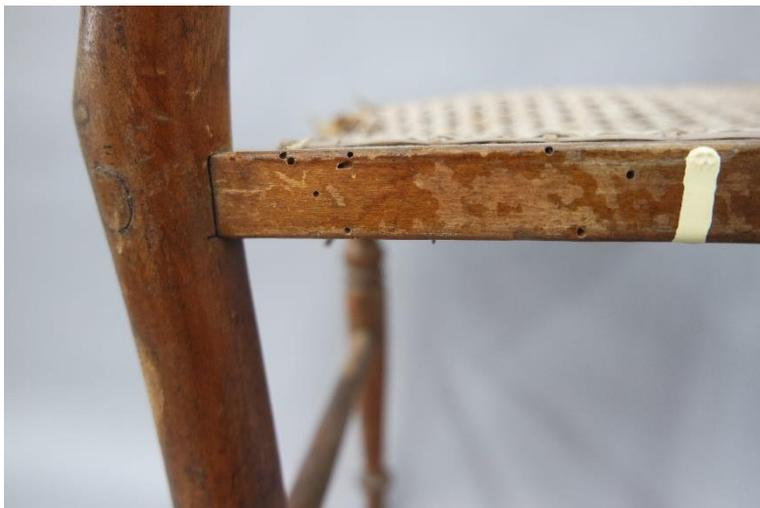
Fig. 15  
Detail view on the seat frame from the back depicting, woodworm holes and paint drip.

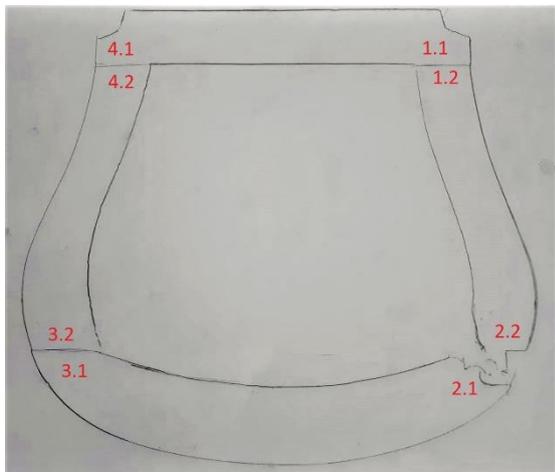
Fig.16 outline drawing of the seat frame

All but the proper left back (nr. 1) mortise and tenon joint of the seat are broken.

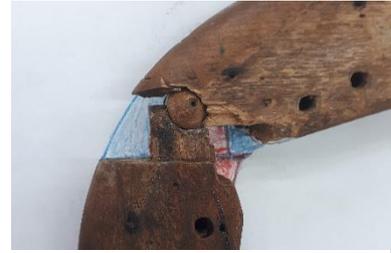
*Figure 1 left side front seat rail mortis and tenon*

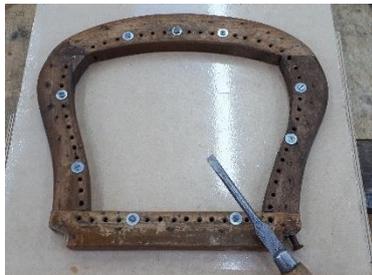
*Figure 2 glue setup seat frame*

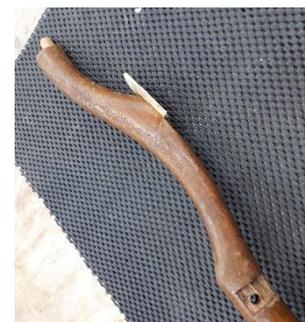
*Figure 3 addition on right upright*

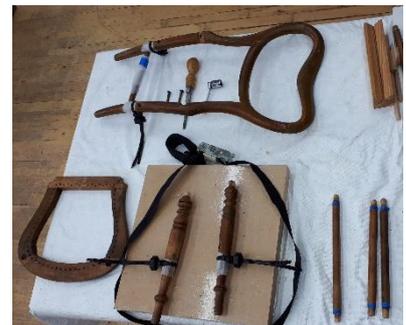
*Figure 5 parts ready for reassembly*
