Conservation of furniture and related objects

Condition and treatment report

| Object Longcase clock case | |

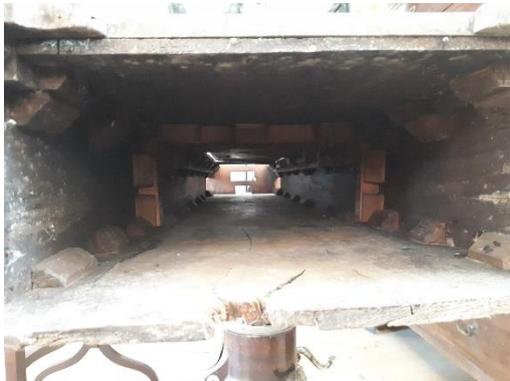
Pic.1

- There is no bottom present, but the structure shows evidence that there had been one. (pic. 1)

Because the chosen piece of oak was of low quality (cross grain, knots, splits and cracks) the back has warped and become proud, leaning backwards out of the hood. The back seems to be stable enough to uphold the case. (pic. 1)

- New bottom is made from oak and coloured with van Dijk brown, water pigment and held in place with hide glue.

- The back is stable and is left as is. The gap that appeared on the top because warping of the back piece is closed by adding some additional timber to close the gap. By doing so the mechanism of the clock is more protected from incoming dust. These additions where made from oak and coloured with a van dijk water pigment to blend the new part in with the existing object. Hold in place with hideglue.

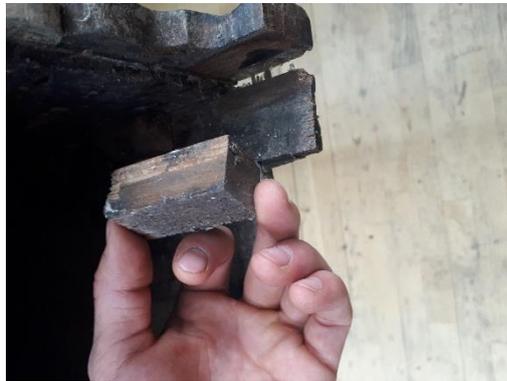
pic.2

-The p. left back foot is missing this block, where the block of the p. right back foot is detached.

(pic.2)

- The p. left front foot is given a coat of paraloid® b67 with oil paint and renicanse wax. The missing block is made new, of oak and coloured with Van dijk® water pigment. This block is glued in place using animal glue.

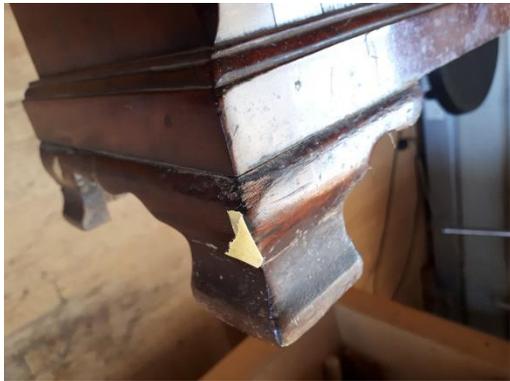
Pic.3

- The ogee parts are loose on the p. right front feet and left and right of the back feet. (pic.3,4)

- There are some minor damages on the surface, like scratches. One is present on the p. right side of the front plinth. (pic. 5)
- On the p. right front feet, there is some surface damage. (pic.3)

- The ogee shaped parts of the feet are taken off, cleaned of old glue and the parts are glued back in place using hide glue.

- The scratch on the corner of the feet has been given the same coat of paraloid® b67 with oil paint and renaissance wax.

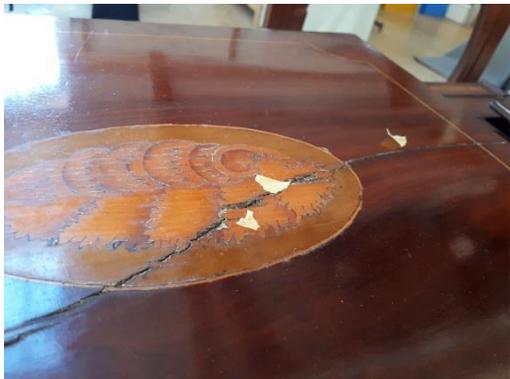
Pic.5

-The most severe crack is vertical through the panel on the front on the base. This has resulted in damage to the conch shell marquetry in the centre of this panel. (pic. 5)

The two parts were levelled, then temporary glue blocks were put on the back of the panel to keep it in place. The split is filled with jelutong wood up until a few millimetres from the surface and glued in place with hide glue The glue blocks on the back can be removed at this point.

. On top, mahogany wood makes the crack blend in with the surrounding area. This mahogany is also glued in place with hide glue, and given a finish of paraloidb72® (15% in shellsol a100) A similar but less extensive method will be used treating the less severe splits. The one on the p. left side had been filled using mahogany veneer glued in place with hide glue.

- The scratch on the on plinth of the base was made less present by the wax coat used for the finish

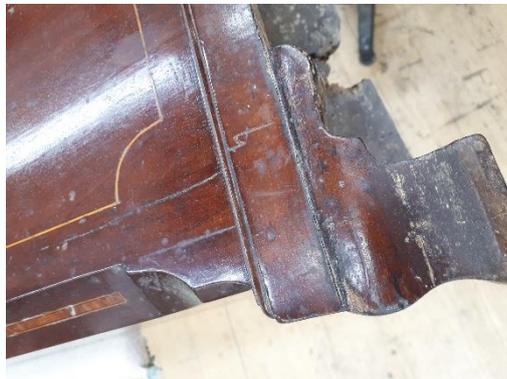
pic.6

A smaller crack is located on the p. right side of the same panel. (pic. 6)

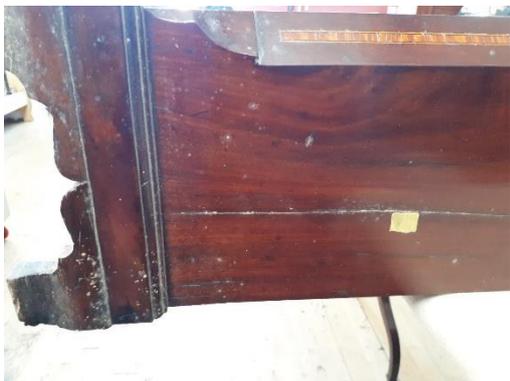
Pic.7

- On the p. right side of the base are two cracks. (Pic. 7)

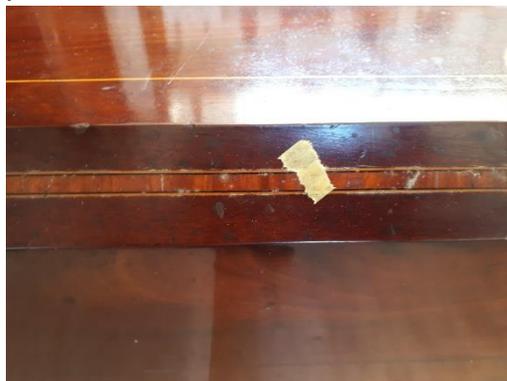
pic.8

- The finish has some spots looking like drips or splatters, which could be watermarks. (pic. 8)
- There seems to be a type of mould growing on several places on the case, on the inside and outside. This mould has a larger presence at the lower parts of the clockcase (pic. 1, 2, 3, 4, 6, 7, 13 & 14)
- There is a build-up of dust present in the numerous corners of the decorative mouldings.

The case has been cleaned, mechanically with a brush and vacuum cleaner, followed by cleaning with deionised water on the finished out side. The bare wood on the inside was cleaned with IMS

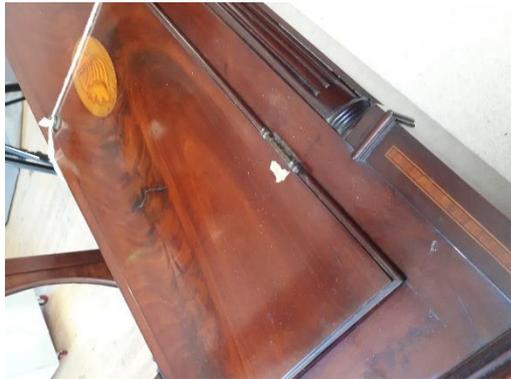
Trunk
Pic.9

- The bottom hinge of the door is loose, there is not enough material for the screw to grip in to.

(pic.9) The hinge has very likely been replaced at some point. This is indicated by a couple of extra holes underneath the hinge plate. The location of the current screw is chosen poorly (on a joint line) which results in this joint detaching. One of these screws is missing.

- The door was taken off and the unnecessary screw holes are plugged. The bottom hinge block on the back of the door was detached and placed back in a more secure, re-adhering with hide glue and placing the screws back. A new screw matching the present ones was added assuring a more firm working door.

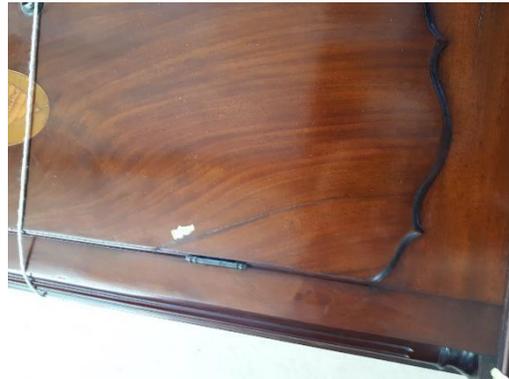
pic.10

- The top left corner of the door has a crack going through it. (pic. 10)

This has seen a previous repair, the evidence for this is the slotted screw present on the back of the door and the sign of animal glue. (as can be seen under UV light (pic.17)) The previous repair failed on the glue line.

- The previous repair was undone and the screw taken out. The joint line was readhered with the use of animal glue. Some missing material left a gap, this was filled with epoxy after applying a barrier

layer. Finally the epoxy infill was coloured using oil paints and sealed using shellac

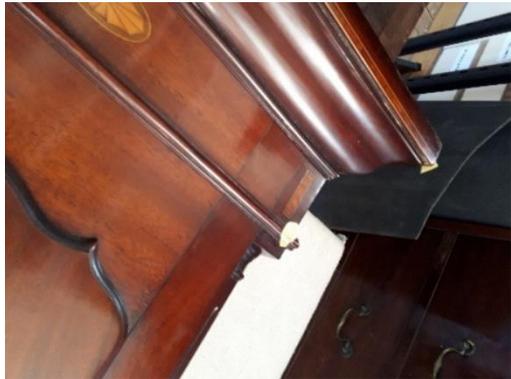
Pic.11

- The moulding strip just above the door is loose in the p. left corner and around the side. Caused by shrinkage of the substrate, the moulded profile strip is loose and too long. (pic. 11)

- The room behind the mitred corner was filled using mahogany wood and glued in place with hide glue.

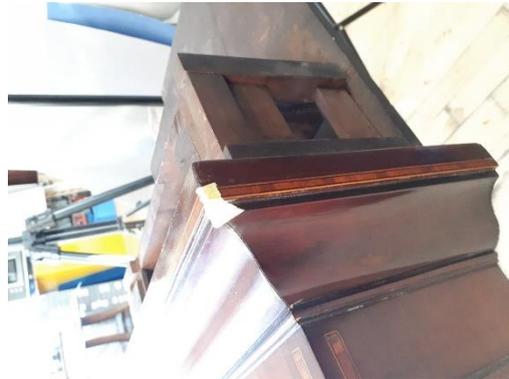
pic.12

- The veneered moulding with stringing right underneath the hood shows signs of nails on the proper left as well as on the p. right side of the case. (pic.12)

- The nail marks in the veneered moulding strip were left as is because interfering might lead to more damage and they do not cause a major concern.

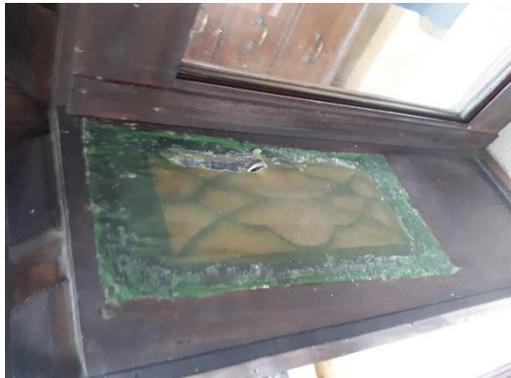
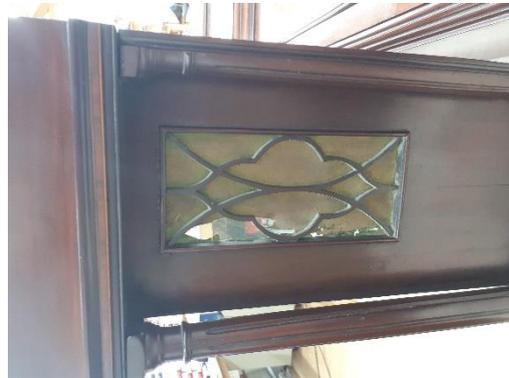
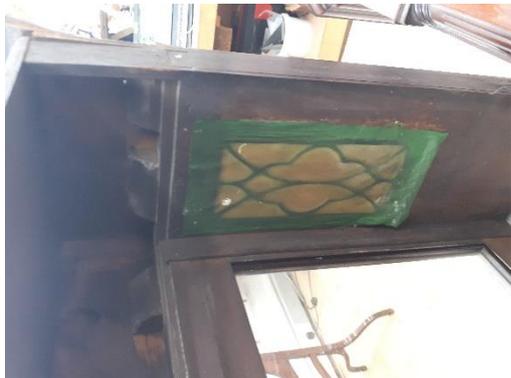
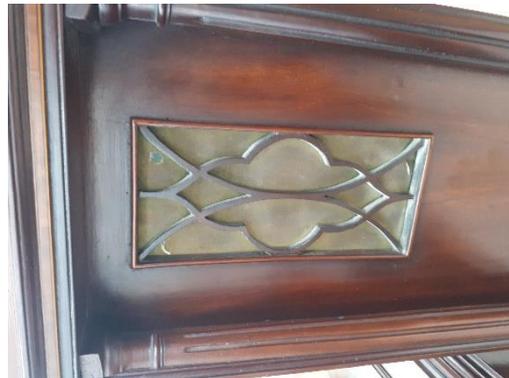
- The fabric behind the fretwork on the hood is damaged and has mould on it on both sides. (pic.13 - 16)

To protect the original fabric and make the clock case dust proof, it was decided to apply a backing fabric. This fabric was coloured with the use of orasol spirit stains and applied with the use of fish glue.

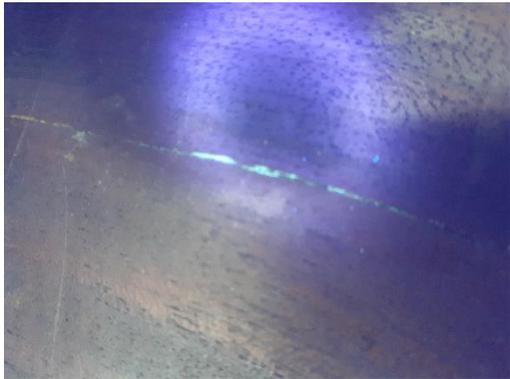
Pic.17 (UV light showing glue)

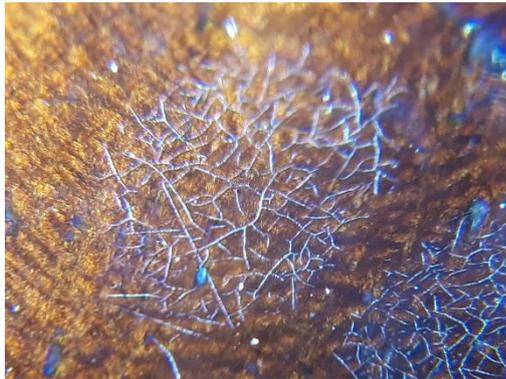
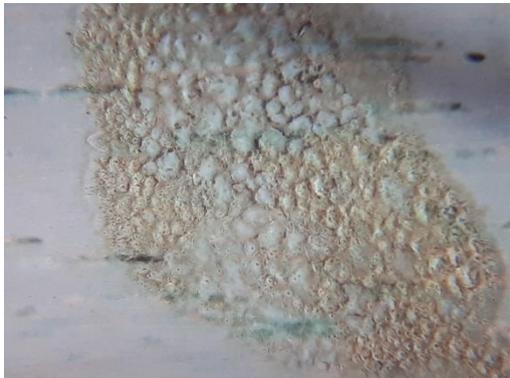
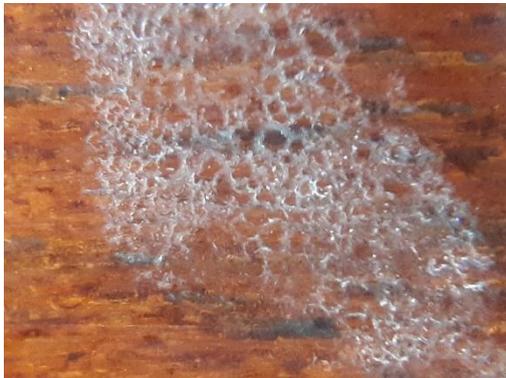
Pic. 18 (magnification of moult damage)

Pic.19 (magnification of moult damage UV)

Pic.20 (magnification of moult damage)
