Conservation of furniture and related objects

Condition and treatment report

WD job no. FU 0008	Date received: 3/7/14
Client name: Christopher Claxton Stevens	Client accession no. 28767
Client preferences: The aim is to return the object in a stable and aesthetically pleasing condition. A condition that makes sense to the period in which it was made. Keeping the patina and the value of the piece, even if that includes stripping it from later adjustments and bad repairs.	
Object Horse fire screen

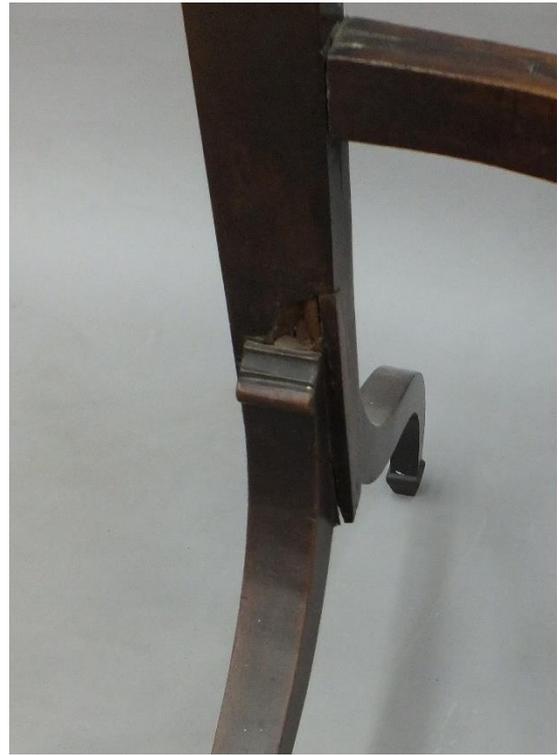
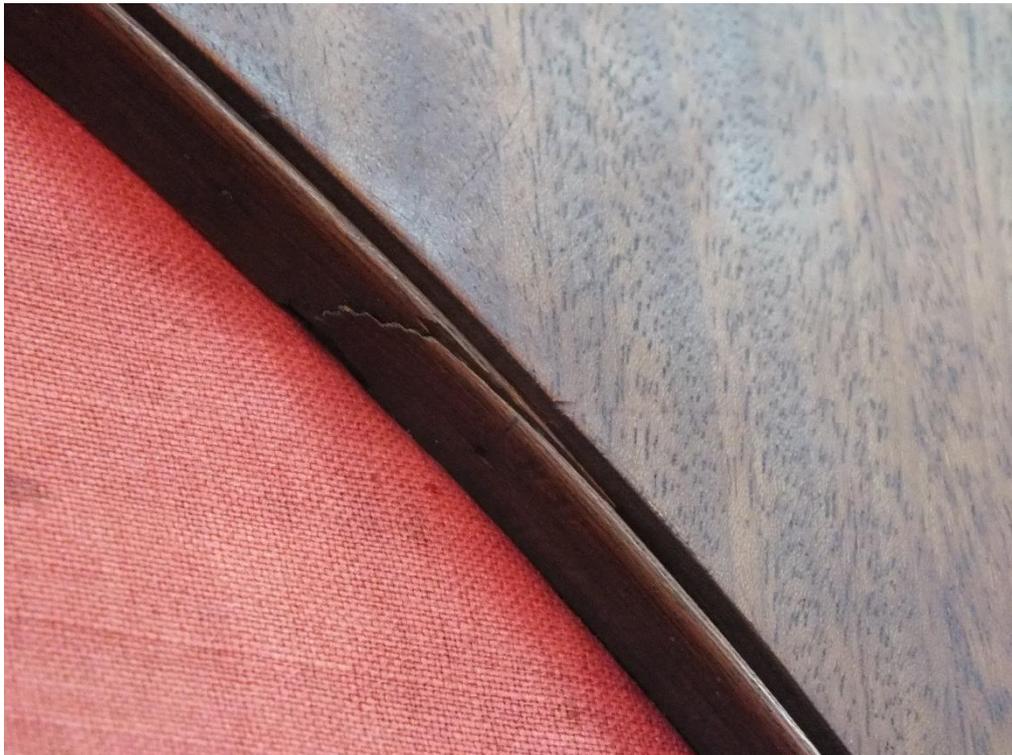
Detailed view of the damage on the upright and the bad repair on the stretcher

- The proper left upright is broken on the bottom end, with the sliding dovetail joint. There are clear signs that a previous repair did not hold even with an additional metal breech, with a messy look as a result.
- Also the stretcher has clearly seen some precious work, both of the tenons at the ends look as if they have been replaced.
- The veneer from the panel has some cracks and chips broken out.
- Both the finials are almost completely missing.
- The dowels that are present on the side of the upright to hold the panel seem out of place.
- The beading that holds the panel in place on the back of the frame is broken at one point.
- The fabric on the upholstered panel is very fragile, the embroidery is missing but left a imprint.

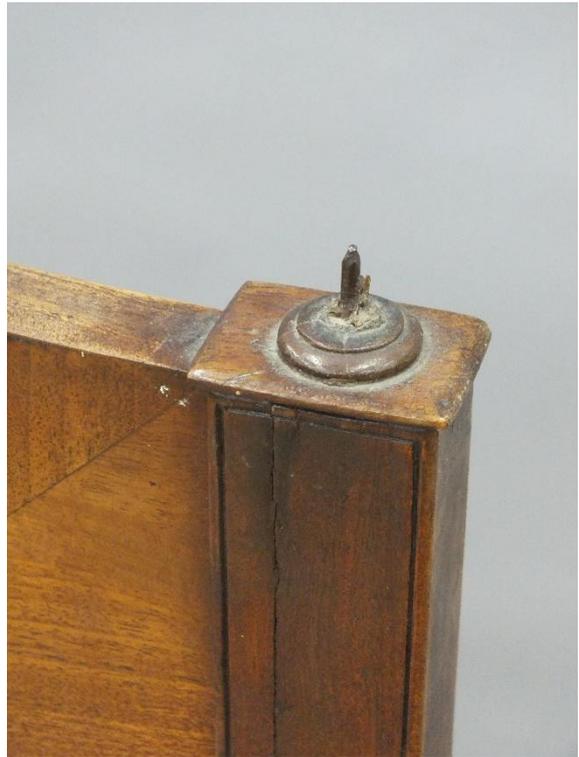
Detailed view of the two missing finials
