Conservation of furniture and related objects

Condition and treatment report

WD job no. FU0204	Date received 5/03/2019
Object

Showcase sideboard rosewood vitrine	
Client private	Client accession no. N.A.

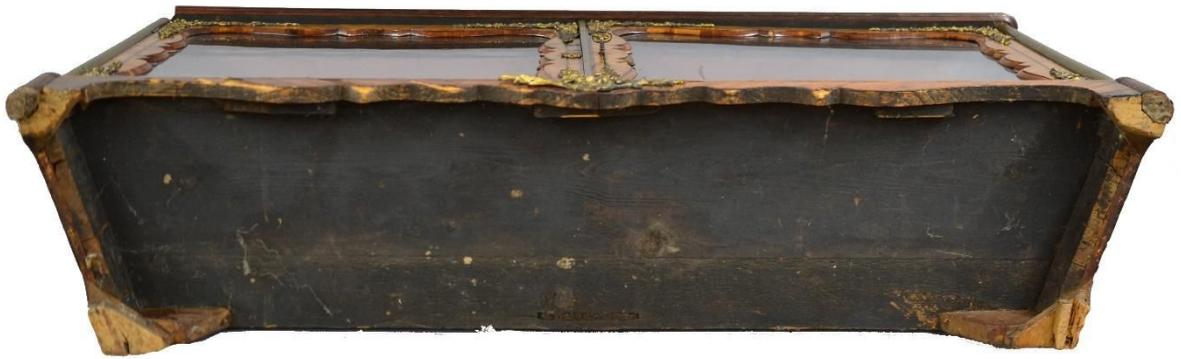
Fig.3 Bottom view

5/6 - There are losses to both feet at the front due to severe woodworm infestation, appears now passive

Losses on feet were replaced with timber and Bencon epoxy putty in order to restabilize the cabinet. Pine supports were adhered with protein glue.

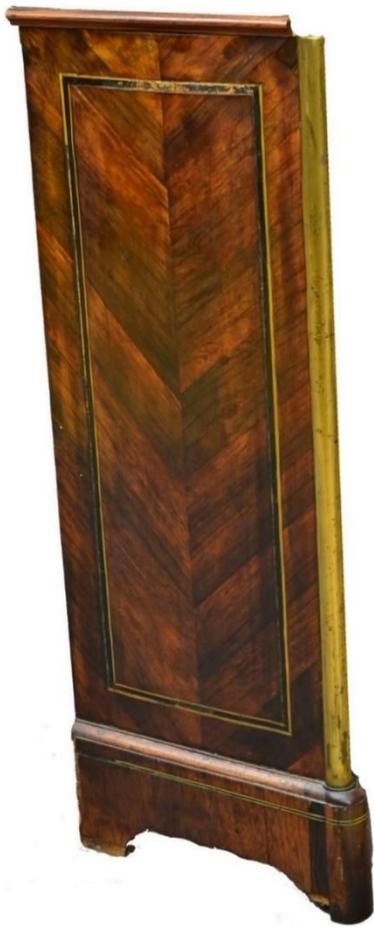
Fig. 4 Proper right side

3/4 - both sides slightly/severely cupped

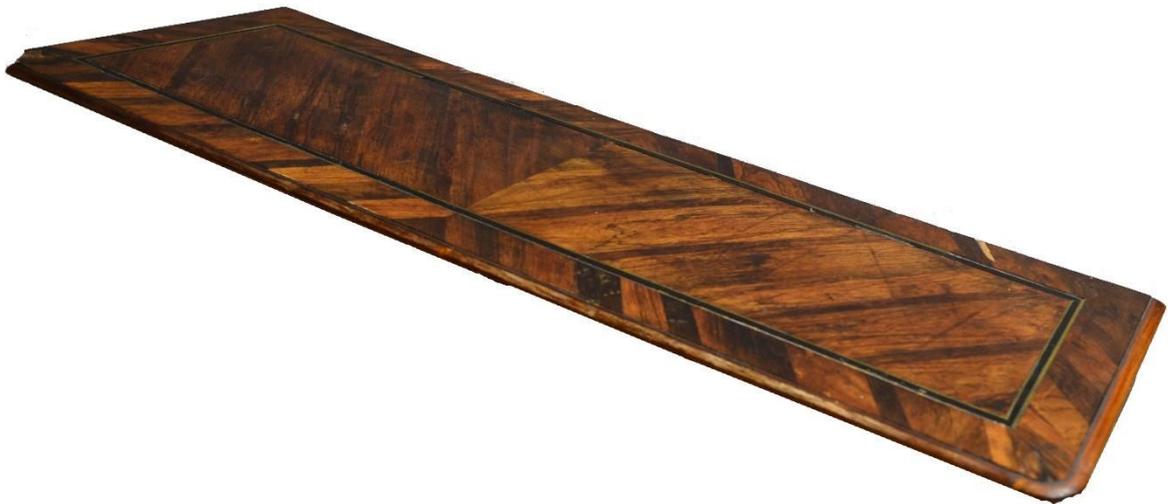
Fig.7 Top

1 – Loose top is slightly sagging in the middle. The veneered top of this object is held on by a number of screws. the middle is not supported and likely due to the nature of the used piece of wood deformed.

The bend in the top piece was left in the wood, and poplar wedges were made to fill out the gap areas between the top and the carcass. Wedges were toned black with water dyes and lightly adhered to the carcass with protein glue.
